Stanford Research Systems

Troubleshooting RGAs

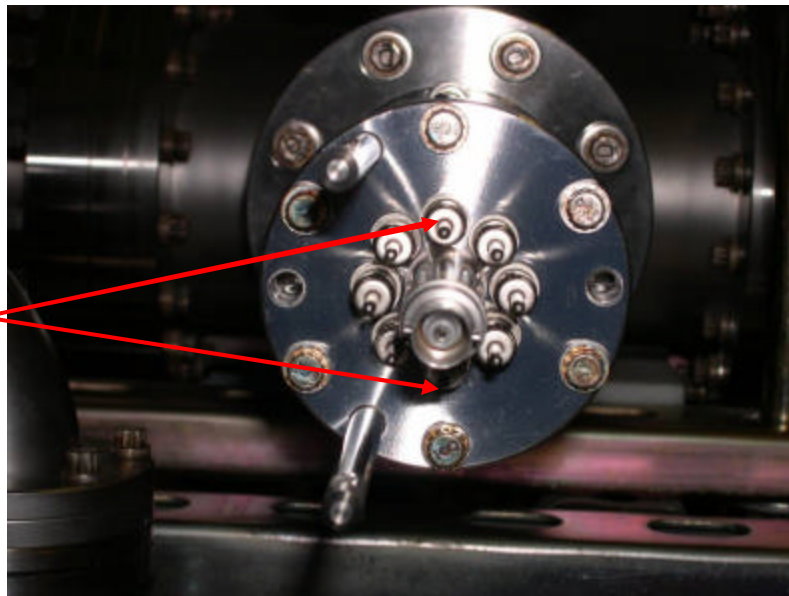
Filament Supply and
Return

1. Check the total pressure in your chamber. It should be below $1e-4$ Torr.
2. Next, in the RGA Windows software, go the Head Menu, and set everything back to defaults. Scan again. If this does not help, go to the next step.
3. The most likely problem is a burnt/broken/degraded filament. Even though you may not see the Error/Burnt/Leak LED light up, the filament may still be damaged.
 - a. Turn off power, and remove the ECU (electronics control unit)
 - b. You will see 8 feedthrough pins on the probe as shown in the manual.
 - c. Measure the impedance (DC resistance) across the filament supply and return pins. This should be less than one ohm. It should not be shorted, or an open circuit. If it is, the filament will need to be replaced.

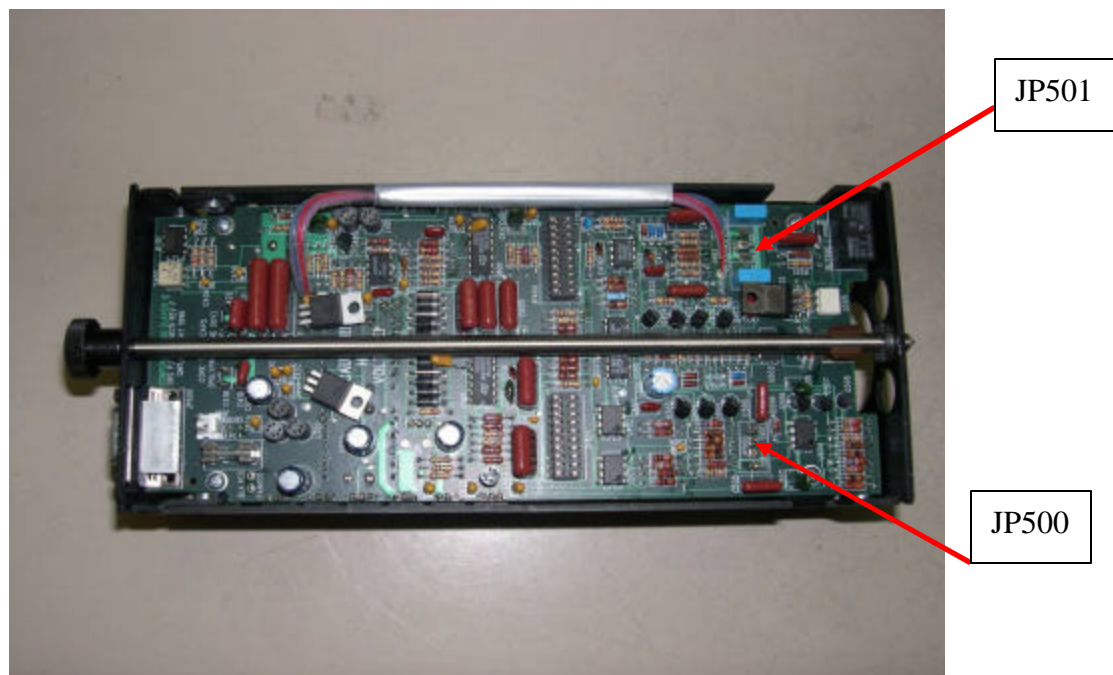
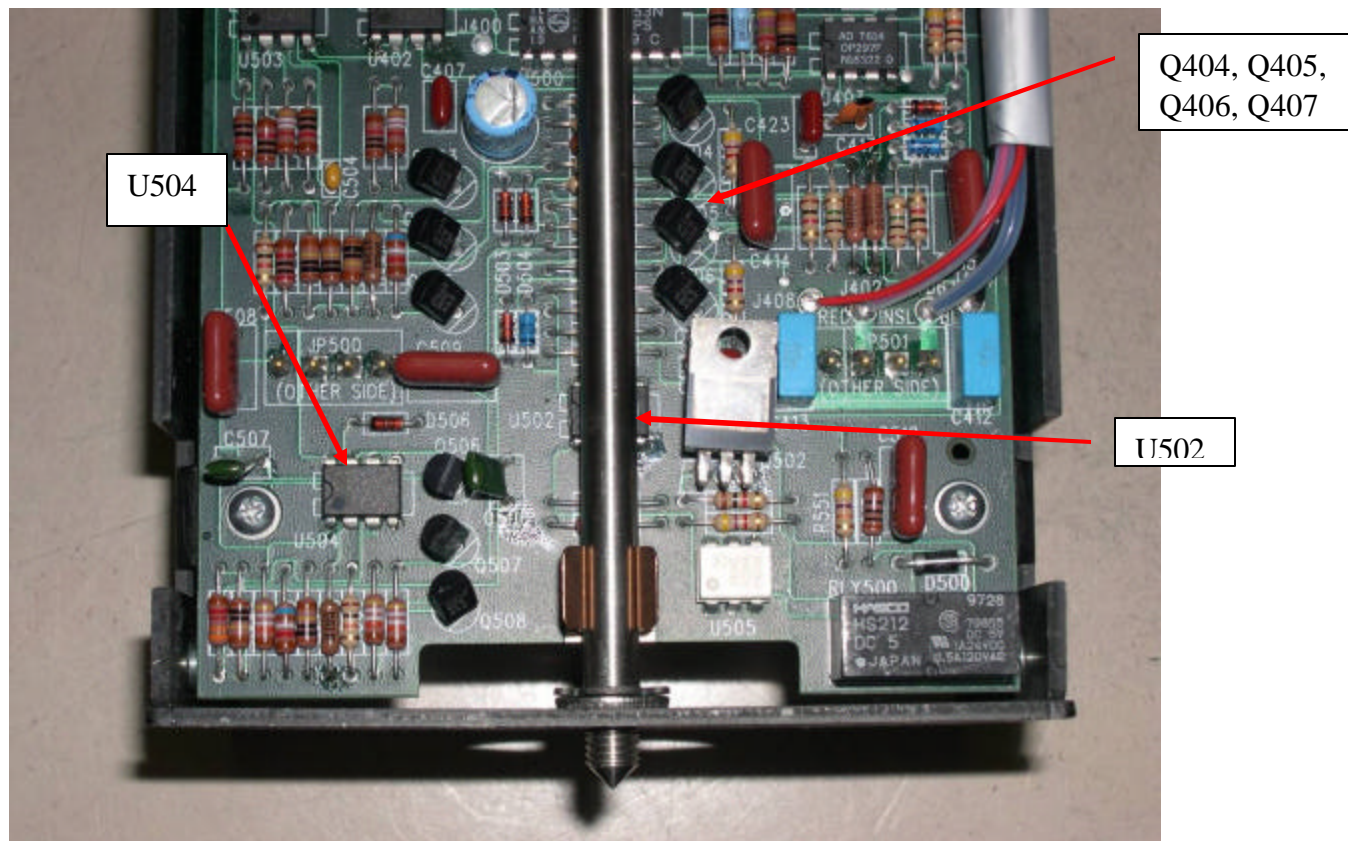
JP500 Voltage Measurement

Expected Voltage	Problem and resolution
Pin 1	-90 VDC	U504 which controls the bias for the focus plate is bad, and will need to be replaced. Part # LM358 (SRS part# 3-508)
Pin 2	0	No connection
Pin 3	0	No connection
Pin 4	-57 VDC	Filament Return Voltage. Contact SRS for repairs

Expected Voltage	
Pin 1	-56.5 VDC	Filament Supply. Contact SRS for repairs
Pin 2	< +2 VDC	+DC Supply for Quadrupole rods. Q404 (MPSA92, SRS Part# 3-627) and Q405 (MPSA42, SRS part# 3-628) need to be replaced.
Pin 3	12 VDC	Anode Grid Voltage. U502 (LM358, SRS part# 3-508) needs to be replaced
Pin 4	> -2 VDC	-DC Supply for Quadrupole rods. Q406 (MPSA92, SRS Part# 3-

627) and Q407 (MPSA42, SRS part# 3-628) need to be replaced.
